A COMPARISON OF

The CNSC Study (June 4 2014):
**Consequences of a
Hypothetical Severe Nuclear Accident**

**The Japanese Government's On-Going
Radioactive Decontamination Efforts (Sept 2013)**

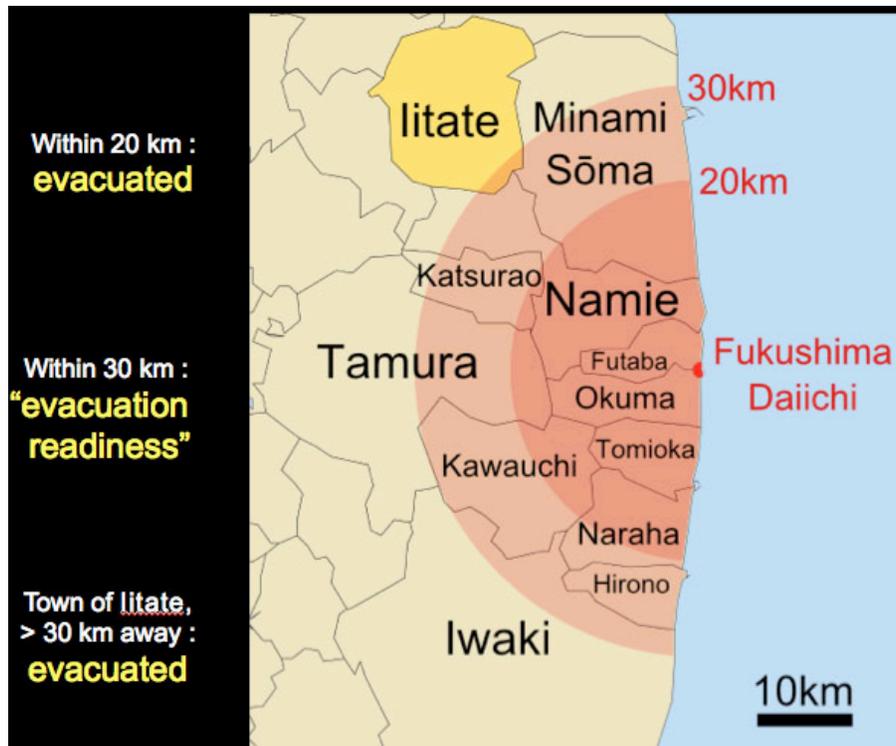
Here is a graphic showing the original evacuation zone (within 20 km of the plant) and the area between 20km and 30km where people were ordered to be "evacuation ready". However, the town of Iitate -- more than 30km away, NW -- also had to be evacuated and remains evacuated to this day.

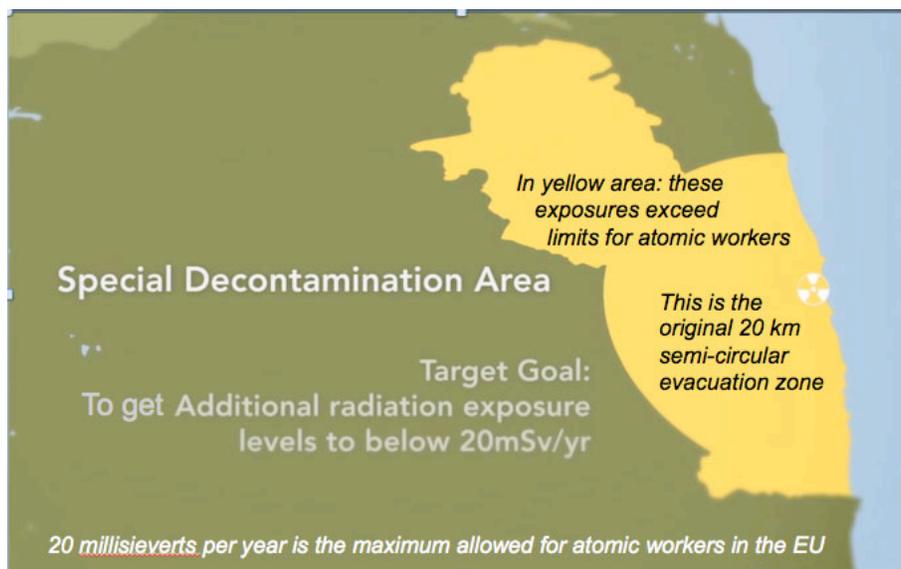
The most heavily contaminated areas include the original 20km evacuation zone and some irregular areas northwest and a bit south of that. In the yellow area, below, the radiation levels (from contamination) are HIGHER than the MAXIMUM exposure allowed for atomic workers in the EU (20 millisieverts per year). More than 2 years after the accident.

The above graphic has been modified very slightly from a September 2013 video by the Japanese Ministry of Environment -- a link to that video is given below in the post-script. Most of the other graphics are also taken from that video.

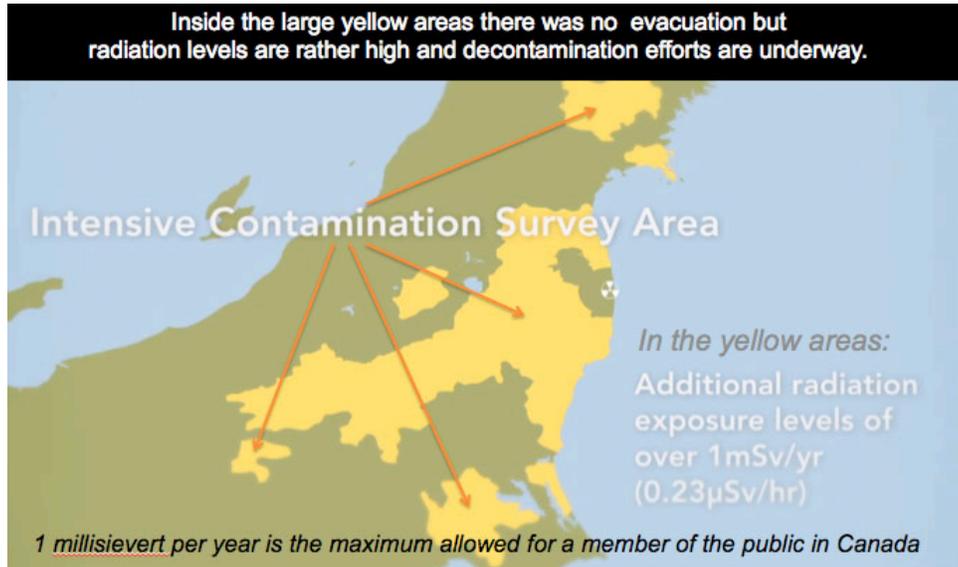
In the next graphic, the "Special Decontamination Area" appears as a green patch inside a yellow area where the radiation levels are BELOW the 20 millisievert/year limit for atomic workers but ABOVE the 1 millisievert/year limit for members of the general public. These yellow areas come right up to the outskirts of Tokyo, about 240 km to the south (SSW).

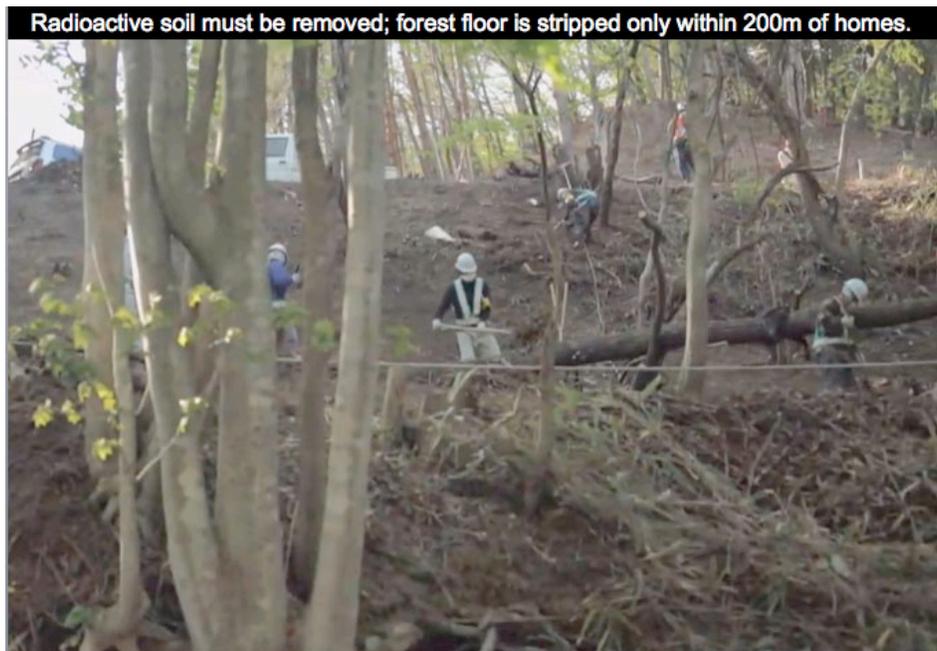
Huge volumes of contaminated soil are dug up and bagged as radioactive waste, including parts of the forest floor within 200 metres of a residence.

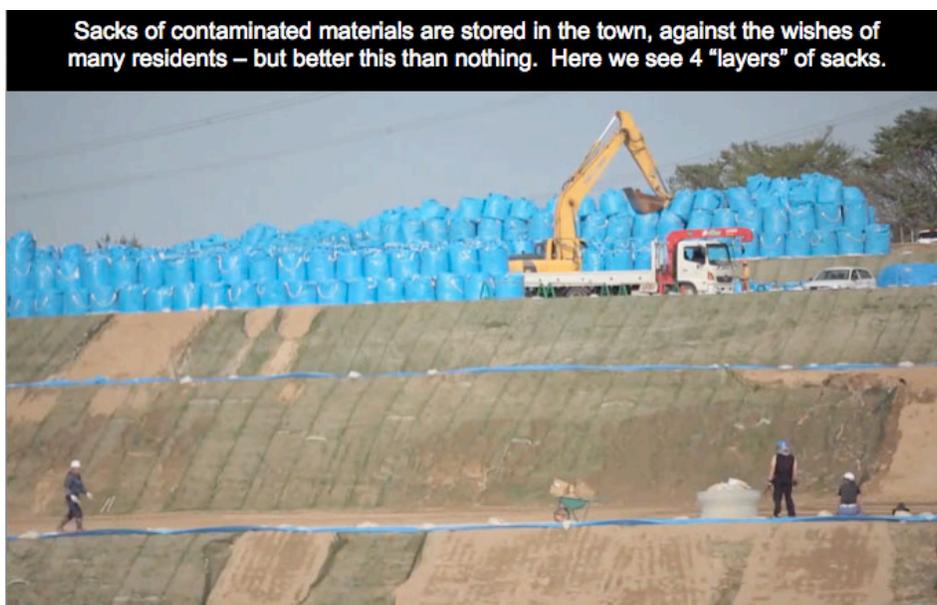
Decontaminating a home takes several days to a few weeks. Contaminated garden soil is dug up and bagged, and replaced with uncontaminated soil. House walls and even garden rocks are scrubbed to try to decontaminate these surfaces, with partial success. The radioactivity is extremely difficult to dislodge from the surfaces where it has "bonded".

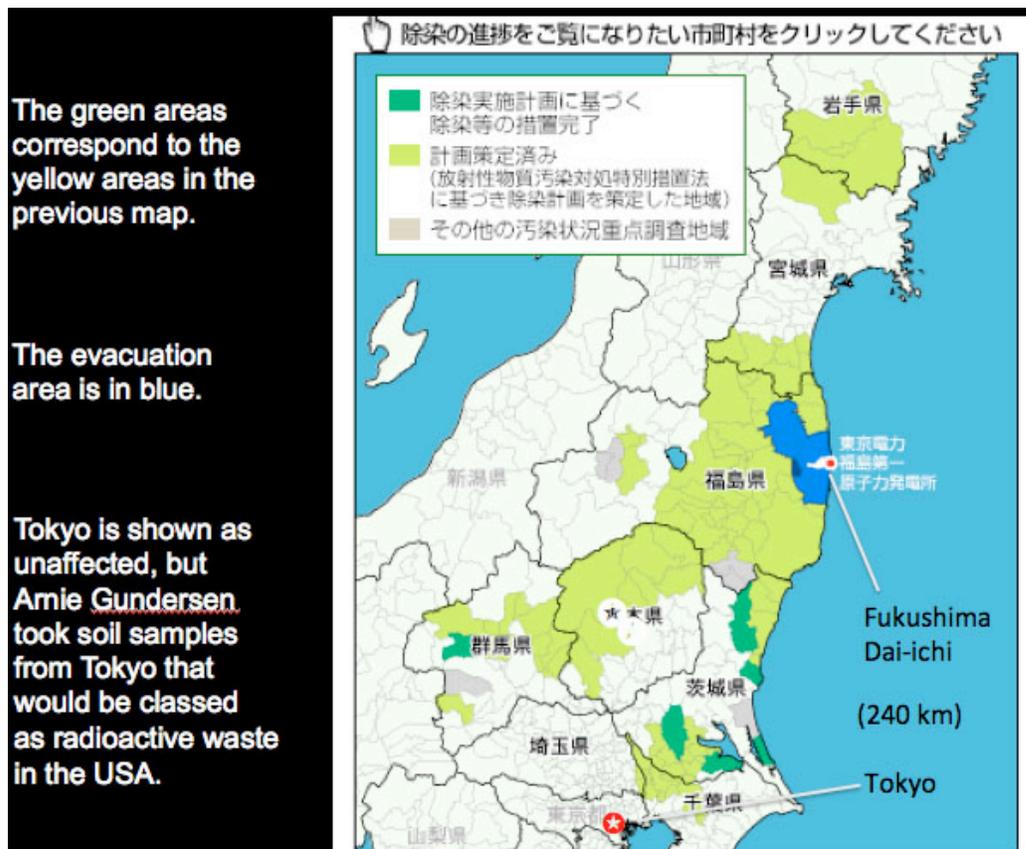
The green areas correspond to the yellow areas in the previous map.

The evacuation area is in blue.

Tokyo is shown as unaffected, but Arnie Gundersen took soil samples from Tokyo that would be classed as radioactive waste in the USA.
